Alignment Assessment Overview

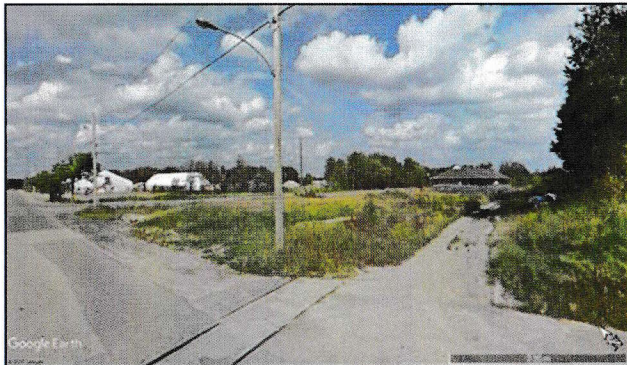
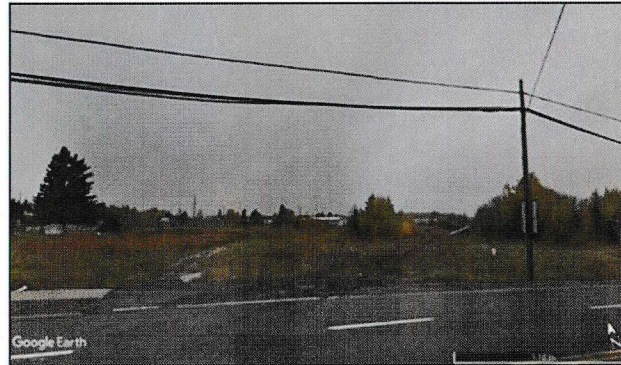
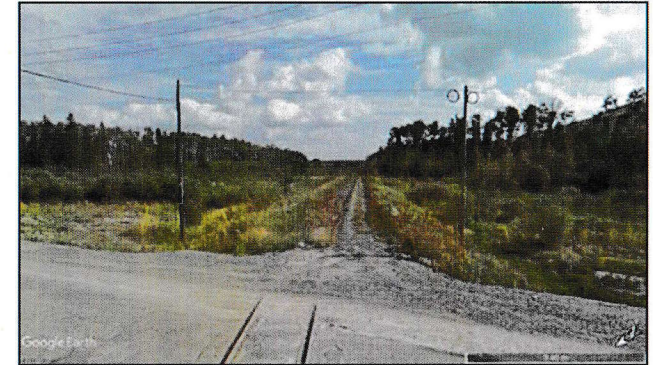
- Timmins: Schumacher Terminal Option
 - Review of the route on Google Earth Street view shows areas where track is overgrown with vegetation, grade crossings that have been built over with no visible track and areas where some utilities look to be within the horizontal and vertical clearance of the vehicle structure gauge. This would need to be confirmed by a detailed survey.
